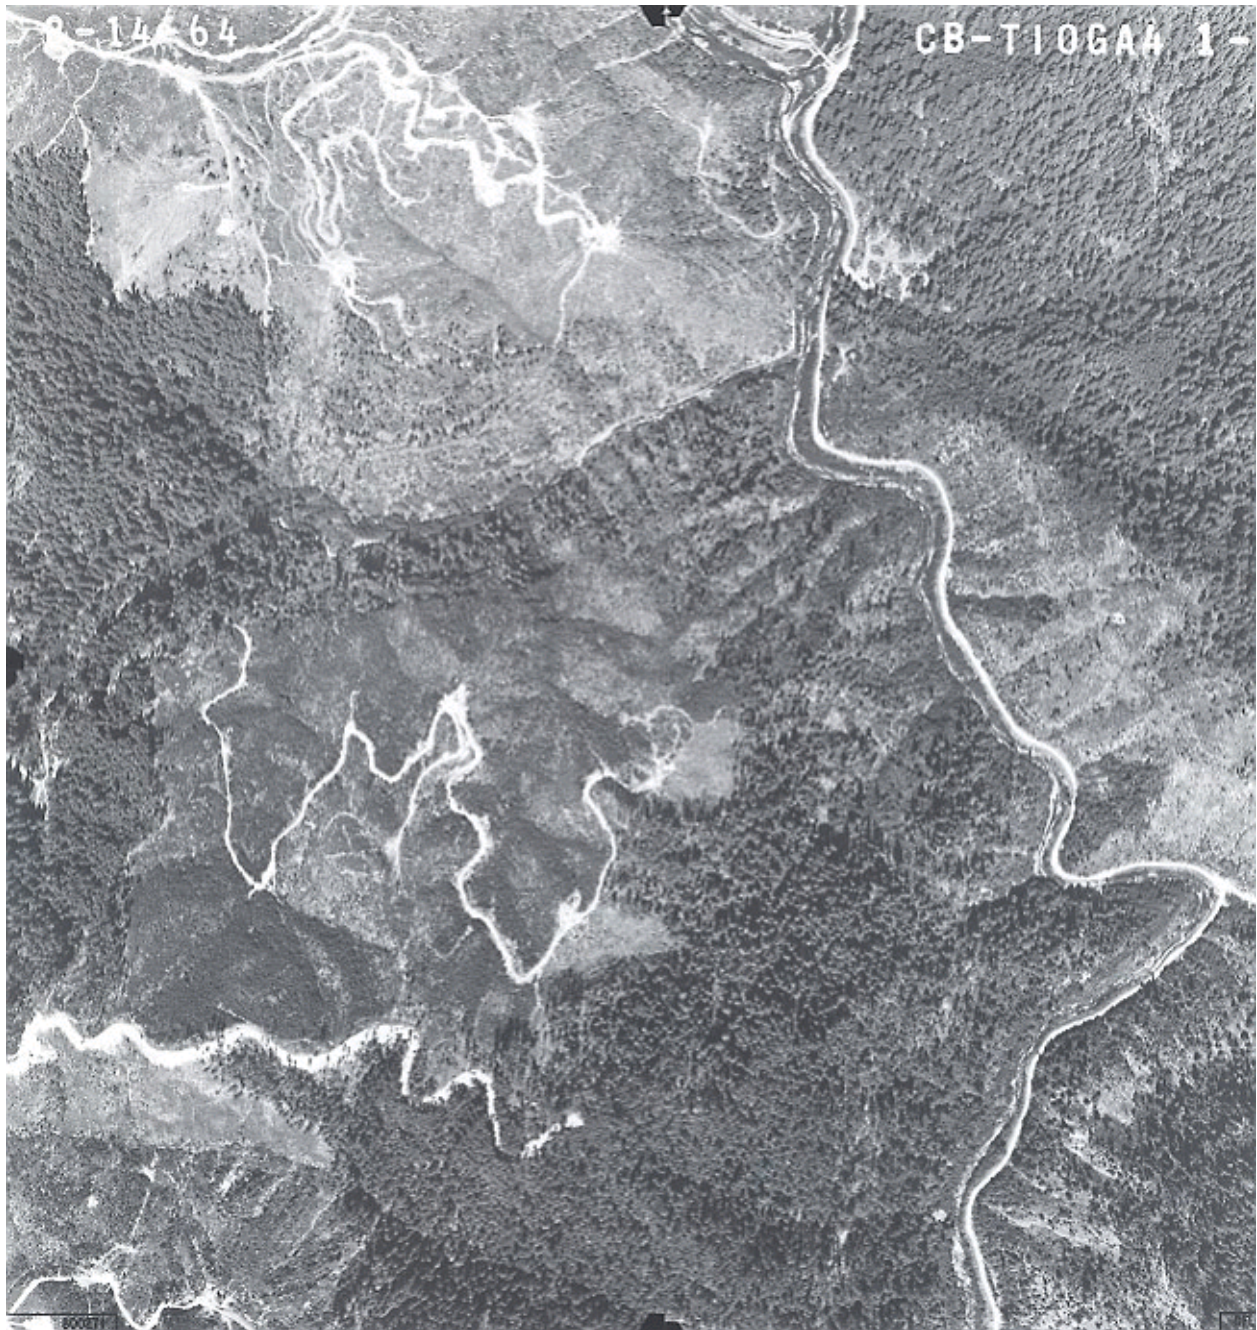
Figure 7: Lower Tioga Creek in 1964. Compare this photo (I-10) to the 1965 aerial photograph (5-10) shown in Figure 8.

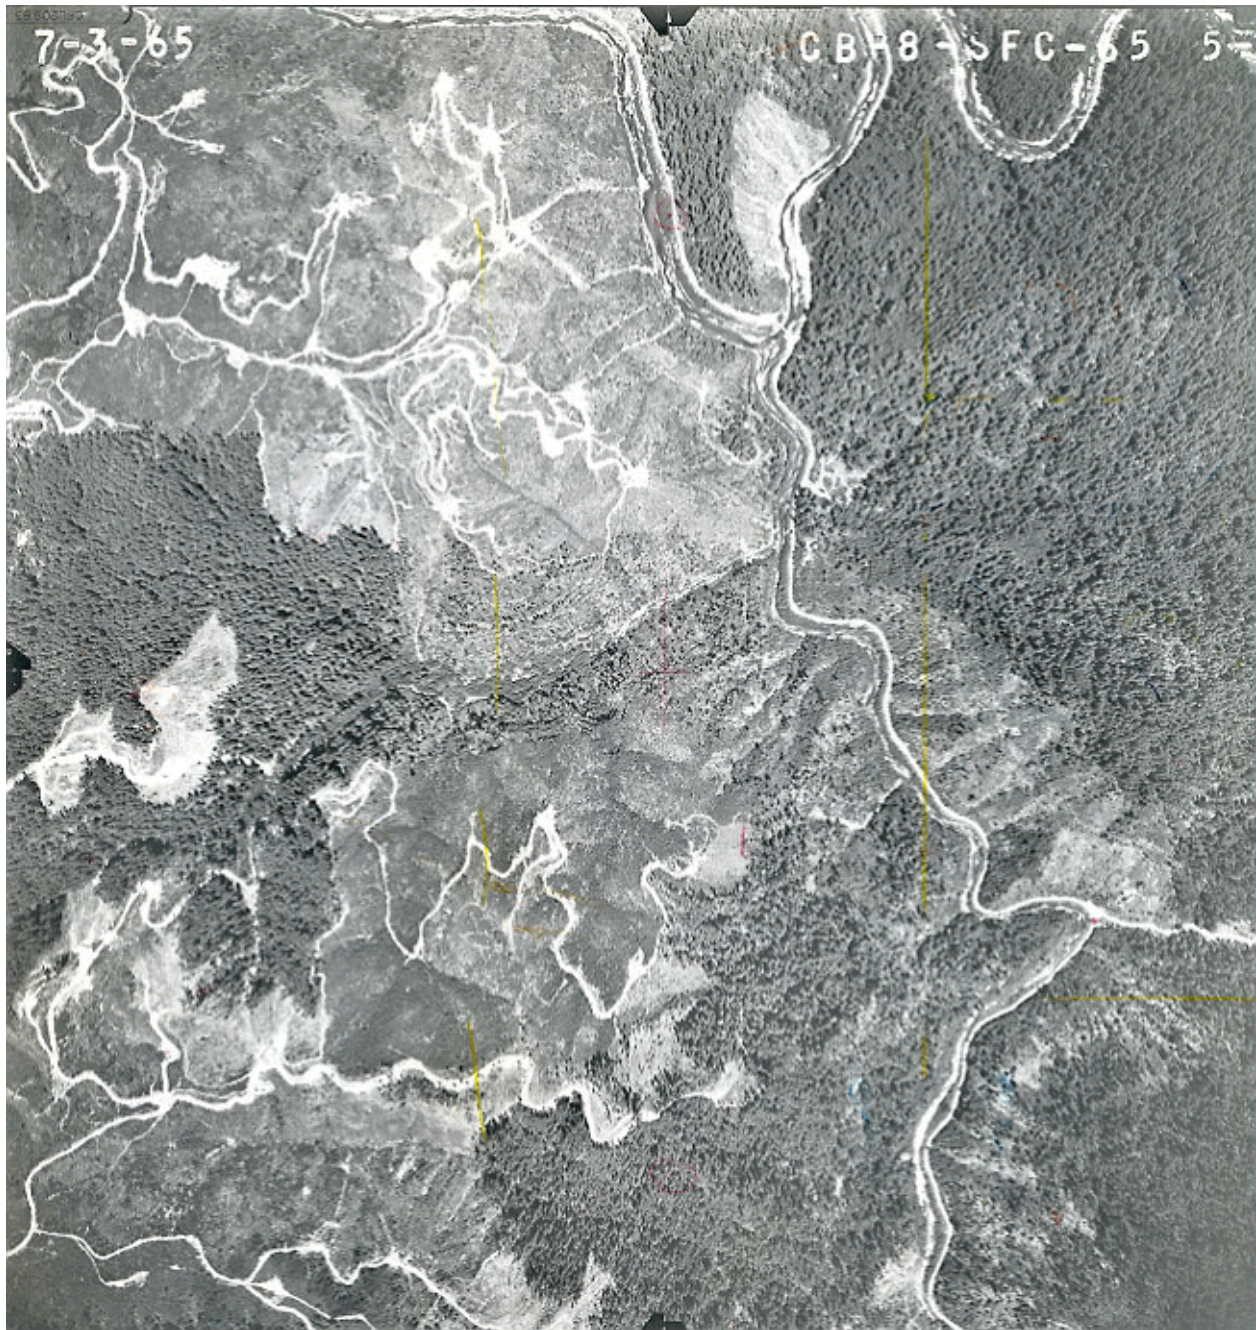
Figure 8: Lower Tioga Creek as shown on the 1965 aerial photograph (Comparison of the 1964 (I-10) and 1965 (5-10) photographs of lower Tioga Creek.

1.35-1.55	Improved gravel supply	
Descriptions of substrate suggest that the braided bars visible in the aerial photos of 1965 had been flushed out of lower Tioga Creek during the late 1960's.

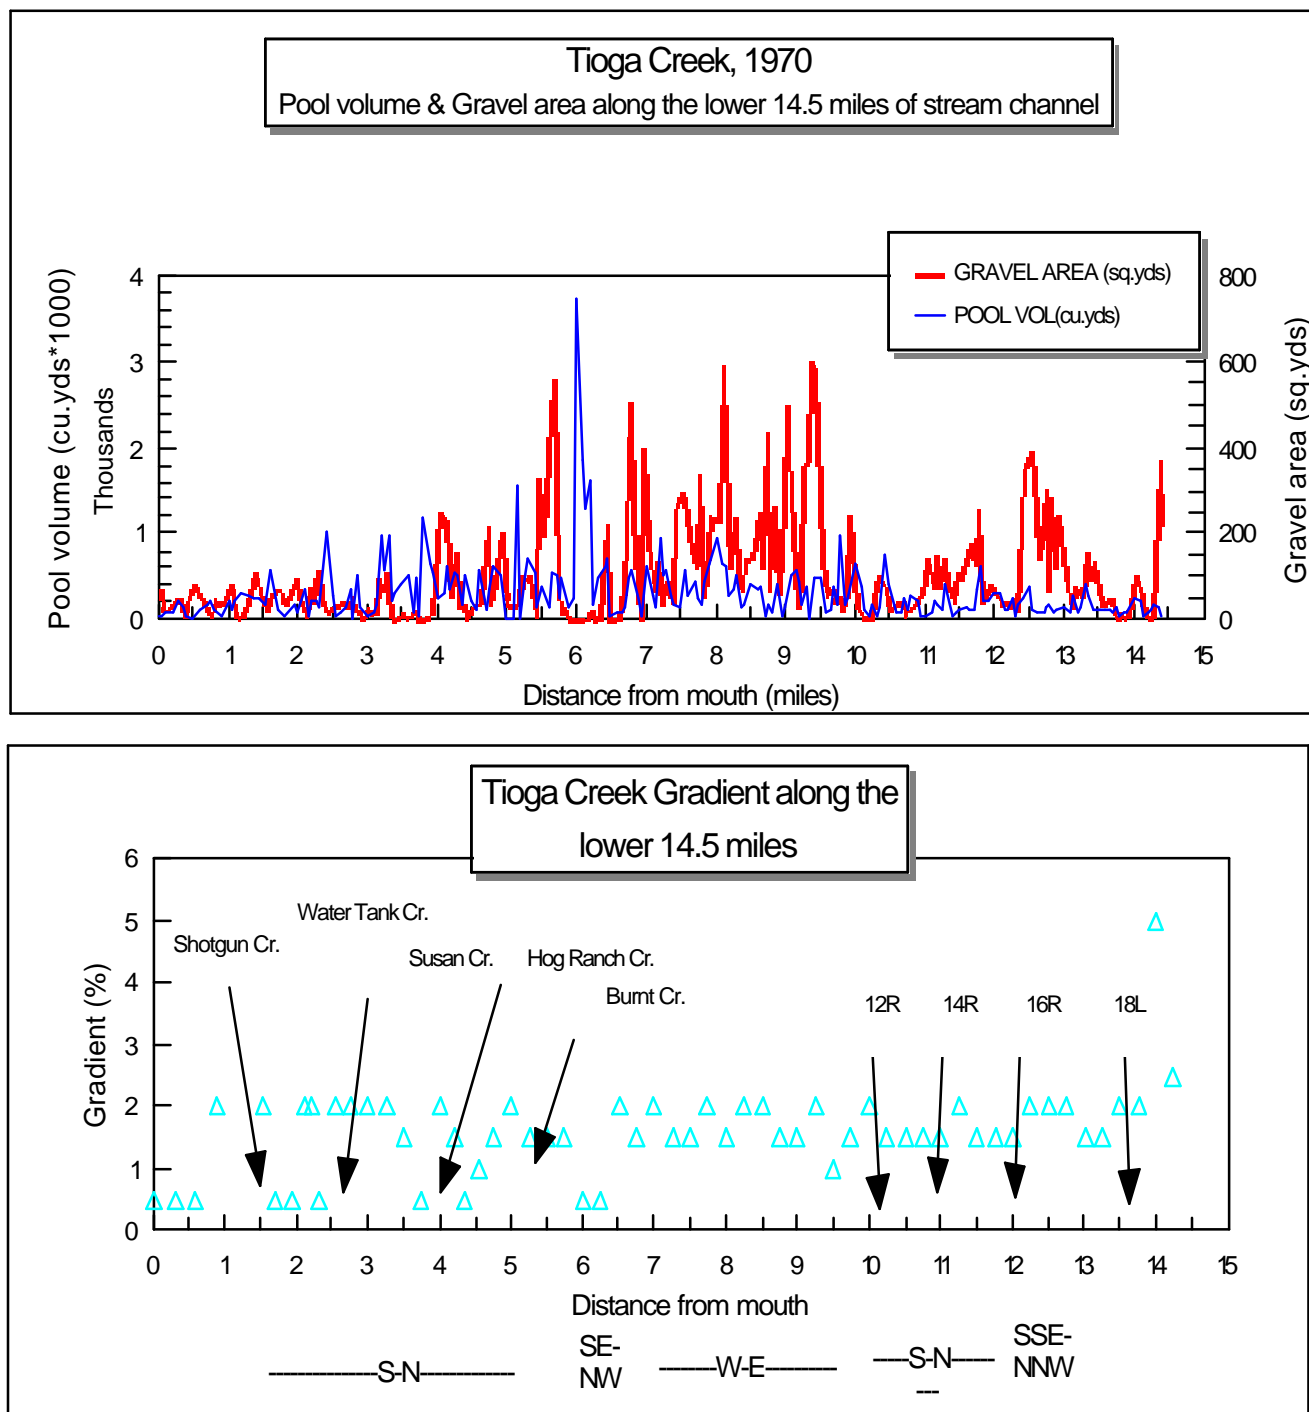
Note in Figure 9(a) that both the area of gravel and pool volume were relatively low in the lower 6 miles of Tioga Creek. Most of the channel substrate was identified as bedrock and boulder-dominated while riparian vegetation was 20-25-year old alder (Table 2). Figure 9(b) shows that the gradient in this reach fluctuated between 0.5 and 2 %. Between mile 6.0 and 9.5, gravel area and pool volumes increased substantially and the gradient is between 1 and 2.5%. This is where the stream valley flows from west to east (Figure 1) and is moderately unconfined.

Between mile 9.5 and 12.5, the Tioga Creek channel became more confined, gravel storage was minimal and pool volumes decreased (Figure 9a).

Figure 9: (a.) Plot of gravel area and pool volume estimates by R. Boyce, 1970.
(b.) Plot of the channel gradient in the lower 14.5 miles of Tioga Creek using Boyce's estimates.

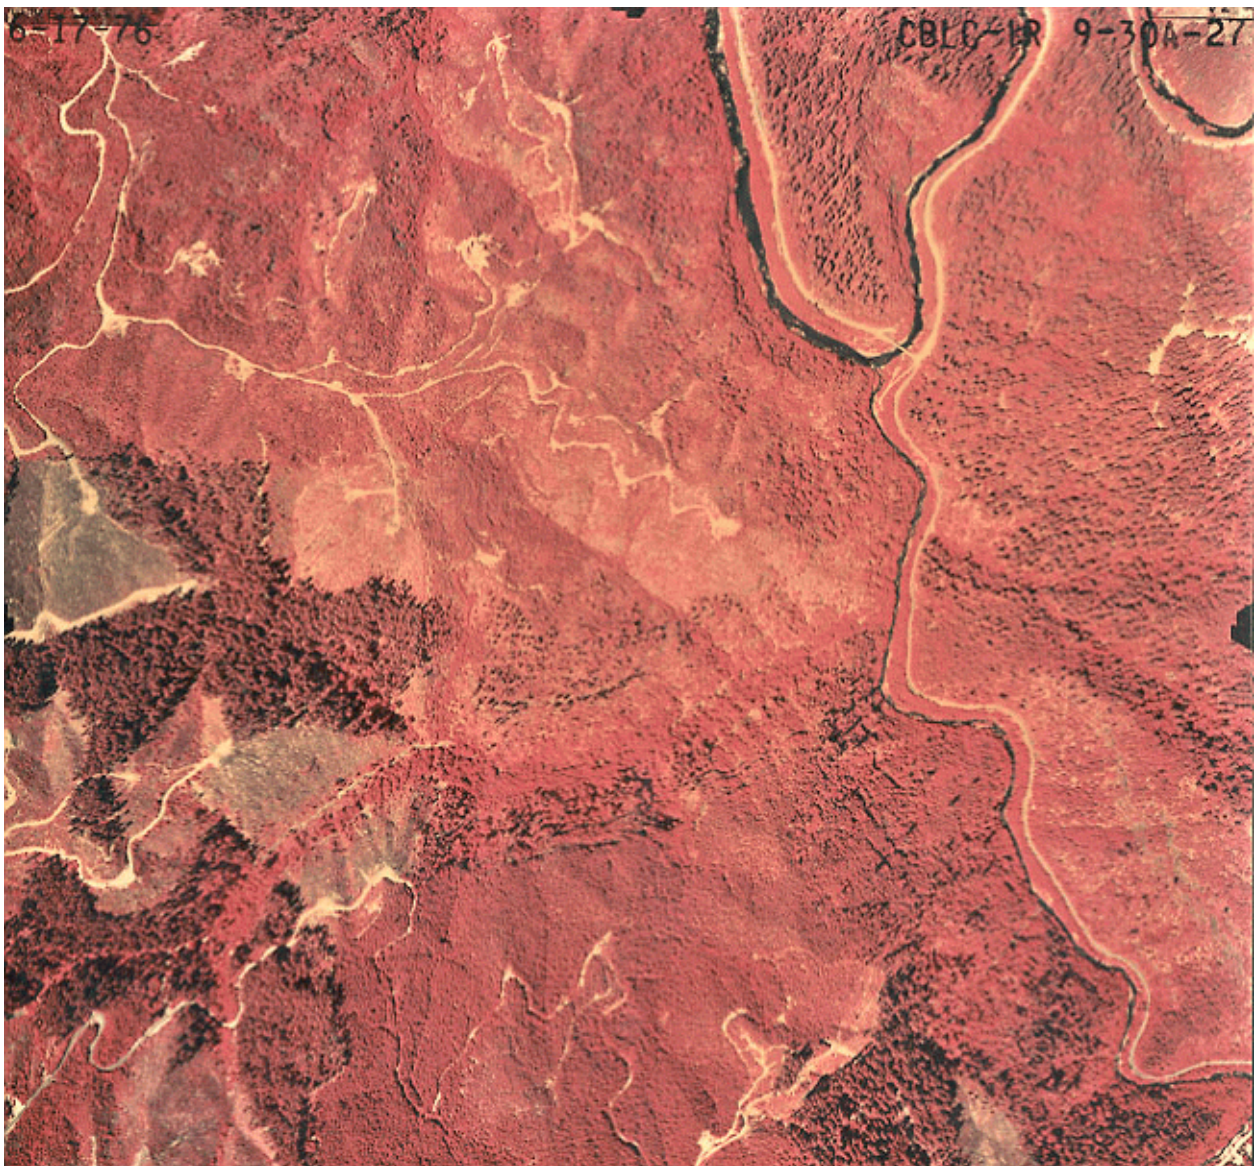
When comparing this color-IR photo set with the 1965 set, the most striking difference in channel morphology, particularly in lower Tioga Creek, was the regeneration of riparian vegetation and the increasing confinement of the channel. This time marks the onset of a **channel degradation phase** in **lower Tioga Creek**. At the mouth of Tioga Creek, the diagonal bars seen in the 1965 photos were gone, having been flushed out, exposing the armor layer of boulder and bedrock. On the banks and some channel bars, a canopy of red alders were forming (Photos 30A-26 through 30A-28 [Figure 10 is photo 30A-27]).

The middle reach of **Hatcher Creek** showed a rotational slump that originated at a road cut in a recently harvested area in the S ½ of the NE ¼ Sec. 13, T 26 S, R 10 W that formed a debris slide or torrent that flowed down a SE-flowing draw and into the mainstem Hatcher Creek (30A-27 [Figure 10] and 30A-28). It ended near the confluence of the two main forks of Hatcher Creek, a distance of about 1,600 ft. The E-flowing draws in the headwaters of Hatcher Creek in the E ½ of Sec. 23, T 26 S, R 10 W, freshly scoured in 1955, did not appear to have been reactivated at this time. The road that had been punched up the Hatcher Creek valley in the 1960's and the timber harvesting in the late 1960's reduced the stability of the channel and riparian vegetation to withstand this debris torrent. This and possibly other events apparently deposited large volumes of woody debris into Hatcher Creek. Stream surveys by Boyce in 1970 (BLM Tioga Creek

Figure 10: The 1976 photo, 9-30A-27 showing lower Tioga Creek and Hatcher Creek. When comparing the morphology of Tioga Creek with that observed in the 1965 photo (Figure 8), note the decrease in channel width, lack of diagonal bars and the maturity of riparian vegetation- all indicators of a reduction in sediment supply and a lowering of the channel bed.

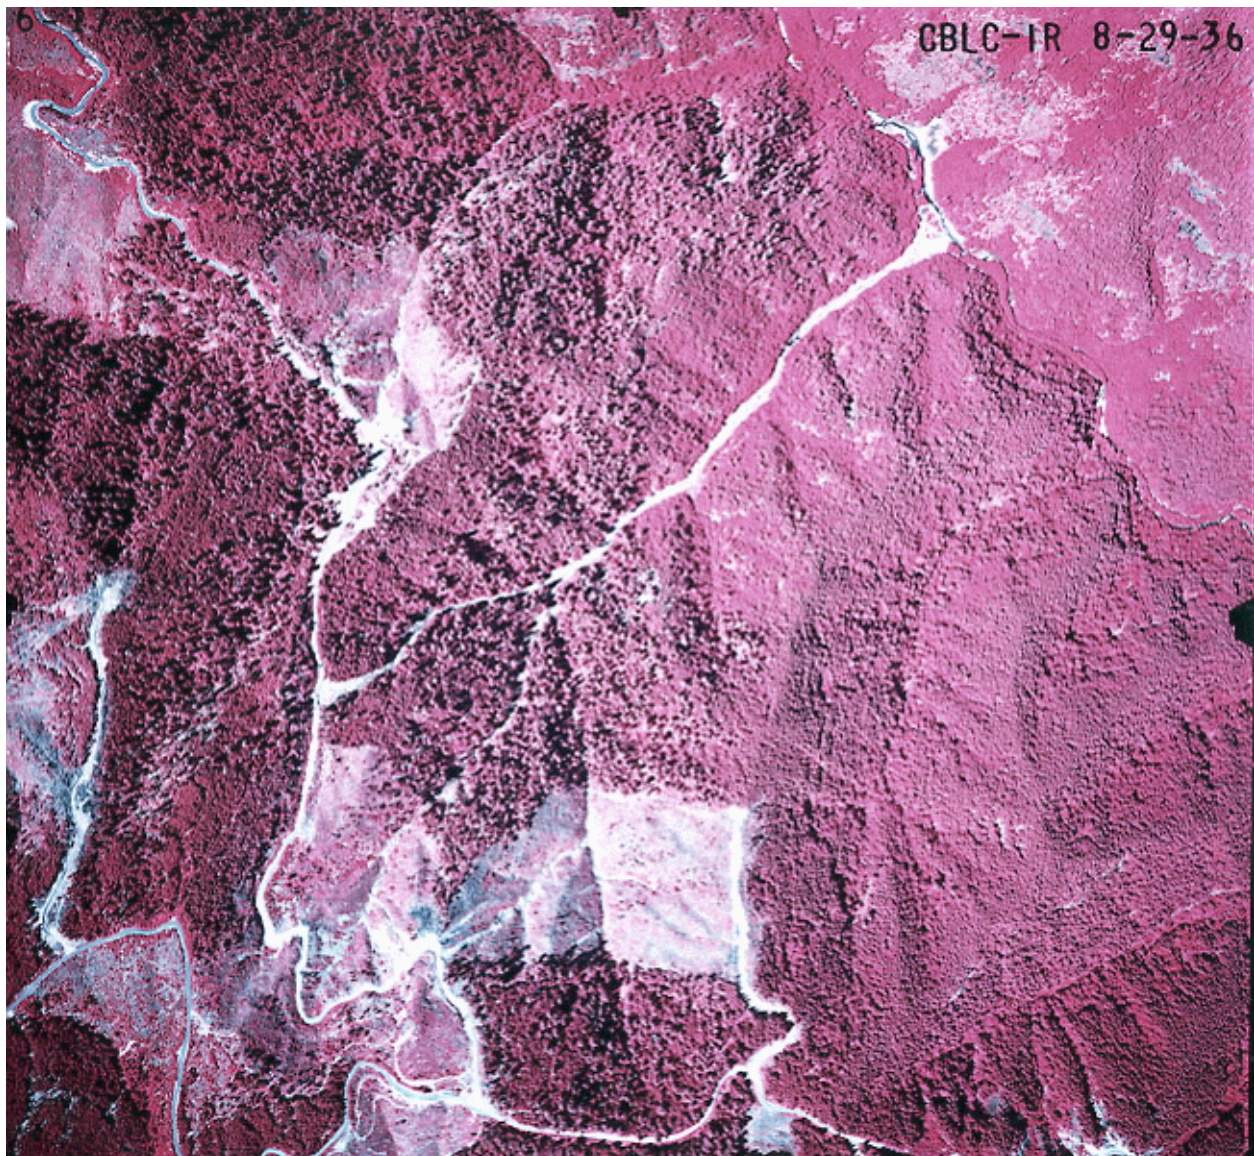
Figure 11: The 1976 photo, 8-29-36 showing Tioga Tributary 14R. Note the rotational slumps originating on the road and the barren nature of the lower valley.

The largest debris torrent evident in all the aerial photographs analyzed was seen in Tioga Tributary **14R** (Figures 11 & 12). Its headwaters of this a NE-flowing tributary draining the NE 1/4 Sec. 14, T 27 S, R 10 W, were recently logged. Rotational failures that originated along the headwaters road formed debris slides that coalesced to form a massive torrent that apparently wiped out virtually every tree in that tributary’s entire mainstem. This torrent apparently affected the right valley wall of Tioga Creek down a few hundred feet downstream of this tributary.

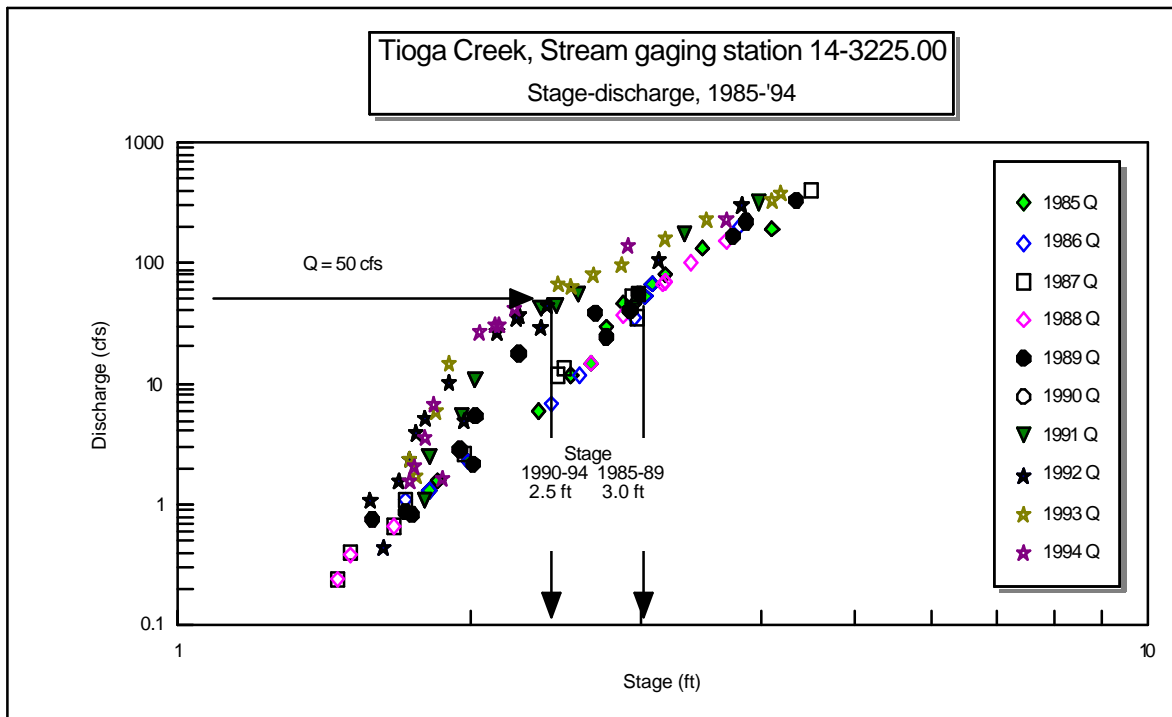
Figure 13 shows that a phase of degradation began during WY 1989 as indicated by the shift of the curve to the left (compare diamonds with solid circles). Degradation continued in the early 1990's which seemed to stabilize by 1992. Between 1985 and 1994, the bed of Tioga Creek at the gage degraded about 0.5 feet as indicated by the stage at 50 cfs.

Figure 13: Plot of stage-discharge for 10 years, 1985-'94. A phase of degradation began during WY 1989 as indicated by an upward shift in the rating curve (compare diamonds with solid circles). Degradation continued in the early 1990's which seemed to stabilize by 1992. In the 10 years of record, the bed of Tioga Creek at the gage degraded about 0.5 feet as indicated by the stage at 50 cfs. **1996 FIELD OBSERVATIONS**
